June 2010

Number 45

# *Conservation Works at St Francis Xavier's Church, Berrima*

## **Introduction**

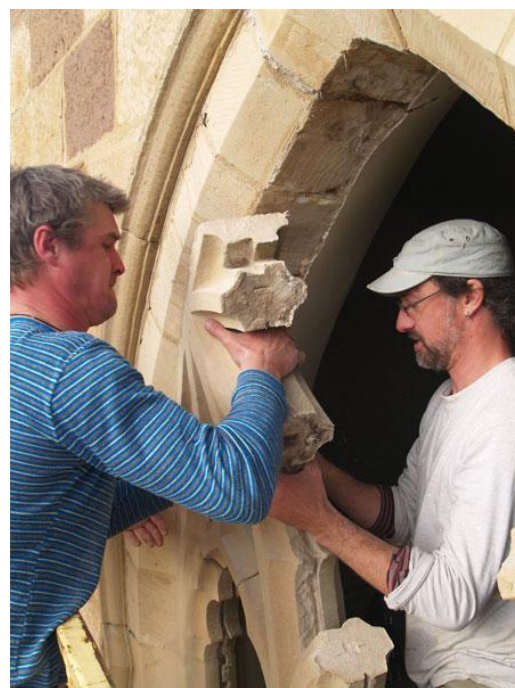
*Removing a piece of stone tracery from the chancel window of St John's Church, Richmond (Image: Brian Andrews)*

We are pleased to report that work on the conservation of the chancel window in St John's, Richmond, is progressing well. Richmond parishioners were recently invited to Gavin Merrington's studio to observe the progress of the conservation and to receive firsthand the 'story' of the 151 years of the window. We include a series of images showing repair of a piece of the window tracery which had fractured due to stress. All the tracery has been removed, repaired and re-set in place ready for the re-insertion of the fourteen conserved stained glass panels which make up the actual window. We will present images of the conservation of the stained glass in the next Newsletter.

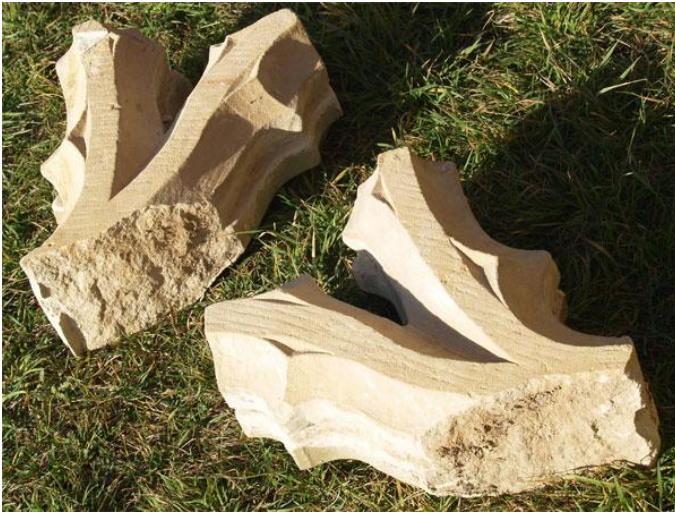
*1. A piece of tracery which had fractured into two pieces due to stress on the stonework (All images: Brian Andrews)*

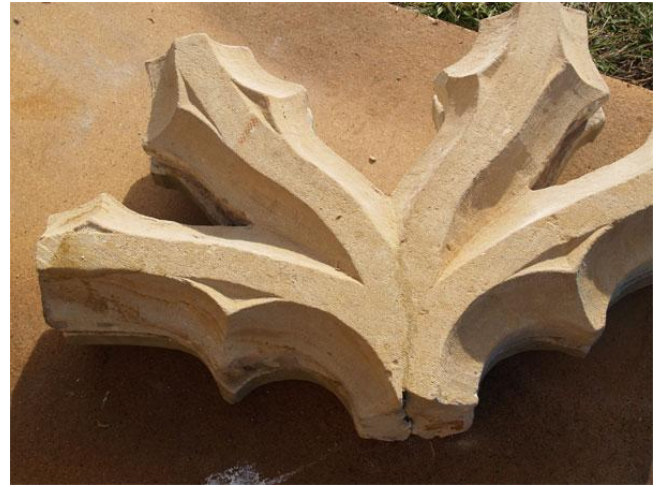
*4. The repaired crack and a filled damaged area at the left-hand end of the left arm of the tracery piece.*

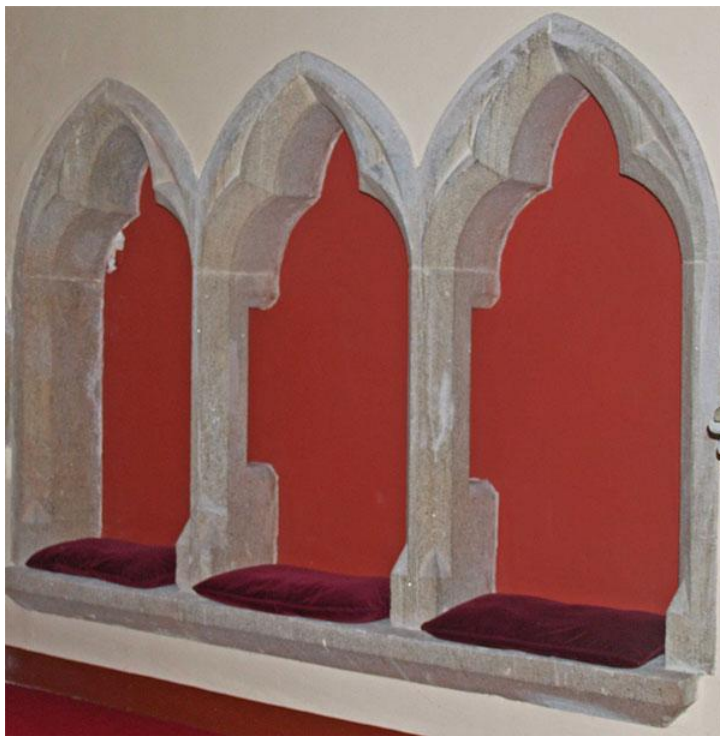
*The Tagoat sedilia (Image: Brian Andrews)*

The sedilia are simplicity itself, having trefoil-headed arches with their simple chamfering extending down the sides of each support to Pugin's much-loved pyramidal stops. The toughness of the design captures well the overall character of this unmistakably Irish church.

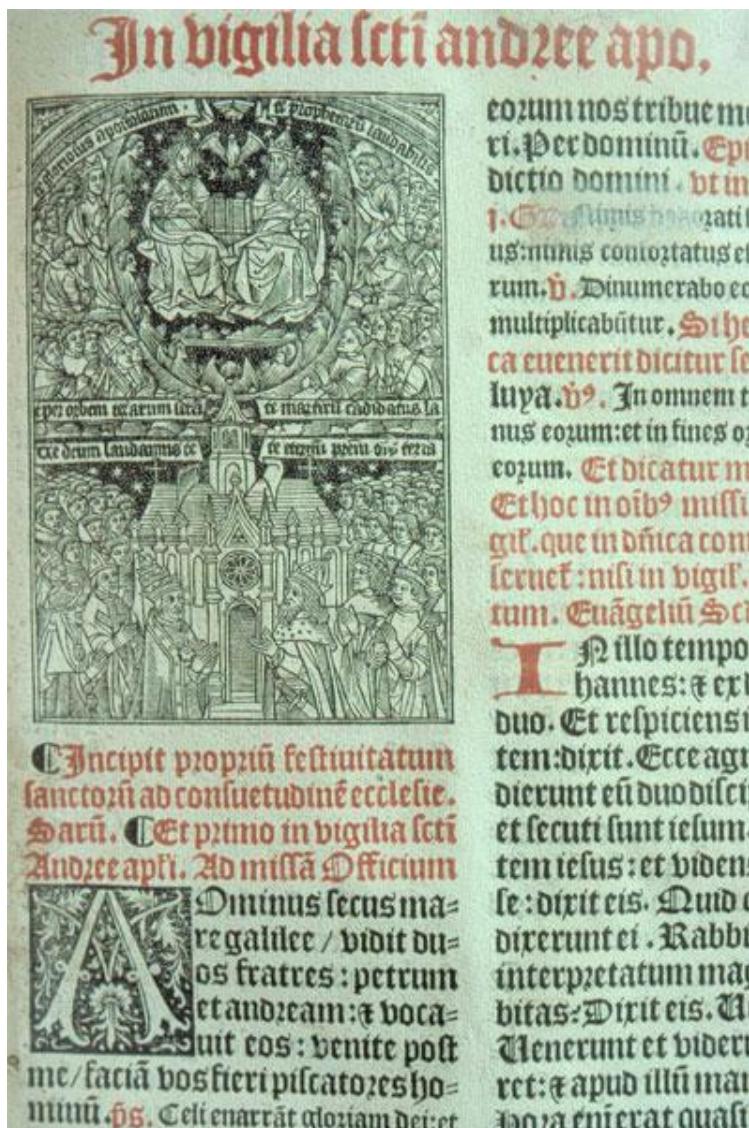
The first is from the vigil of the feast of St Andrew, Apostle, the beginning of the cycle of celebration of saints' feast days according to the Sarum Use. The illustration is a graphical depiction of the ancient Christian hymn, the Te Deum, ascribed to St Nicetas (335–415), the first part of which is a hymn of praise to the Trinity, the praise of the saints and angels in heaven, and of the faithful on earth.

The second is a detail from the feast of Pentecost, the image in the right-hand column depicting that event. It is interesting to note the influence of the

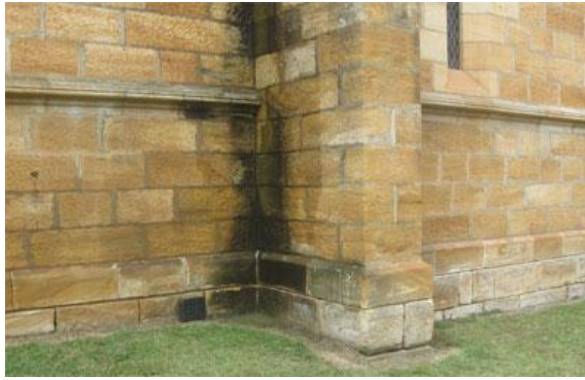
The building has no damp course, and the problem had increased over time because hard cement had been used to re-point stonework near the base of the building, forcing moisture into the surrounding stone with resulting salt contamination and erosion. Dampness had been exacerbated by faulty guttering combined with downpipes discharging against the base of the building

*Saturated stone caused by defective guttering*

To minimize water accumulation near the base of the church all new guttering and downpipes were installed.

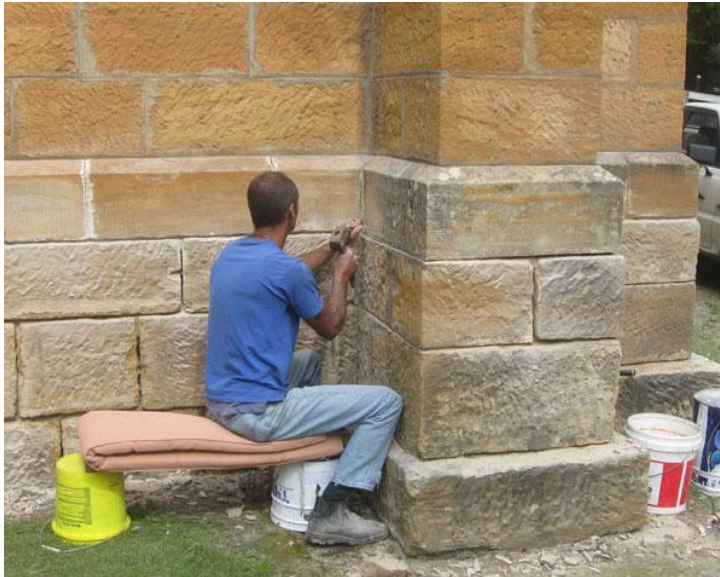
*Above: hard cement mortar being removed; below: a partially re-pointed section of stonework*

The hard cement pointing was chiselled out and replaced with soft lime mortar. Being softer than the surrounding stone, lime mortar absorbs rising moisture rather than does the stone and is thus 'sacrificed'.

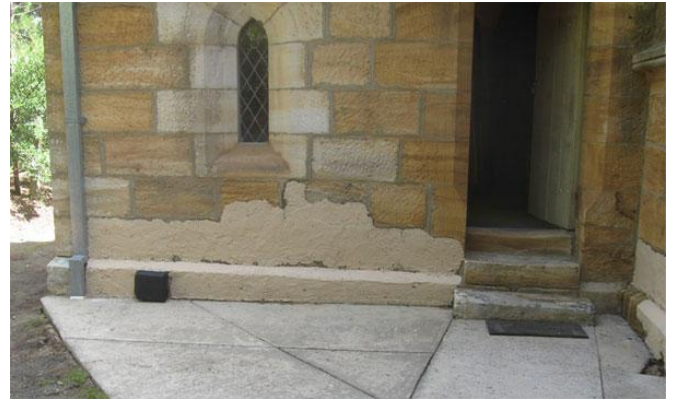
*The 'Westox Cocoon' poultice can be seen applied to stonework near the base of the sacristy east wall and the chancel south wall*

Destructive soluble salt contamination was removed from affected stonework using a method which has been successfully employed on a number of New South Wales historic buildings of high heritage significance. This desalination was achieved by the application of a proprietary poultice called a 'Westox Cocoon' to the affected stonework, then left in place for several weeks before removal.

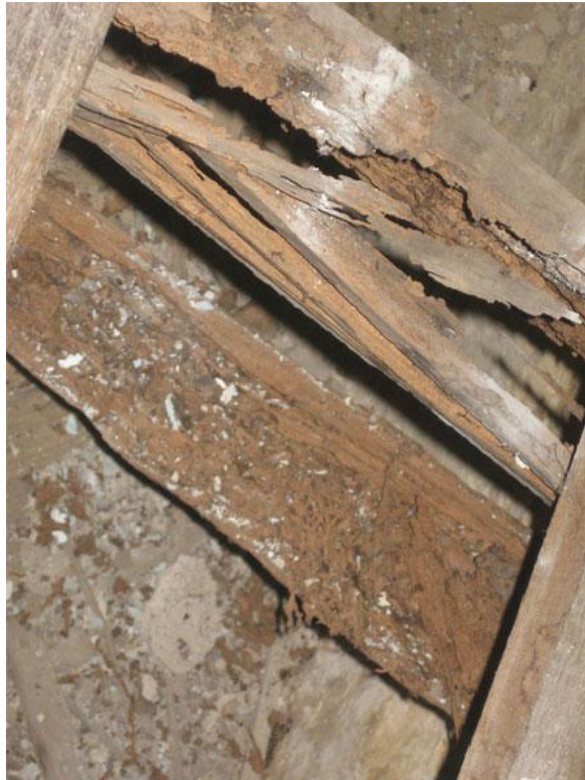
Once areas of the floor known to be rotten were uncovered it was revealed that the entire flooring of the nave and chancel was severely damaged from termite (White Ant) infestation. So bad was it that the only possible course was to entirely remove the old floors and construct new ones.

*A section of rotten flooring*
