The Present State of Pugin's Ecclesiastical Architecture in Australia

Bishop Willson's Hobart Pro-cathedral Renovations

Wind Braces in Pugin's Churches (Part 3)

The Ramsgate Rood

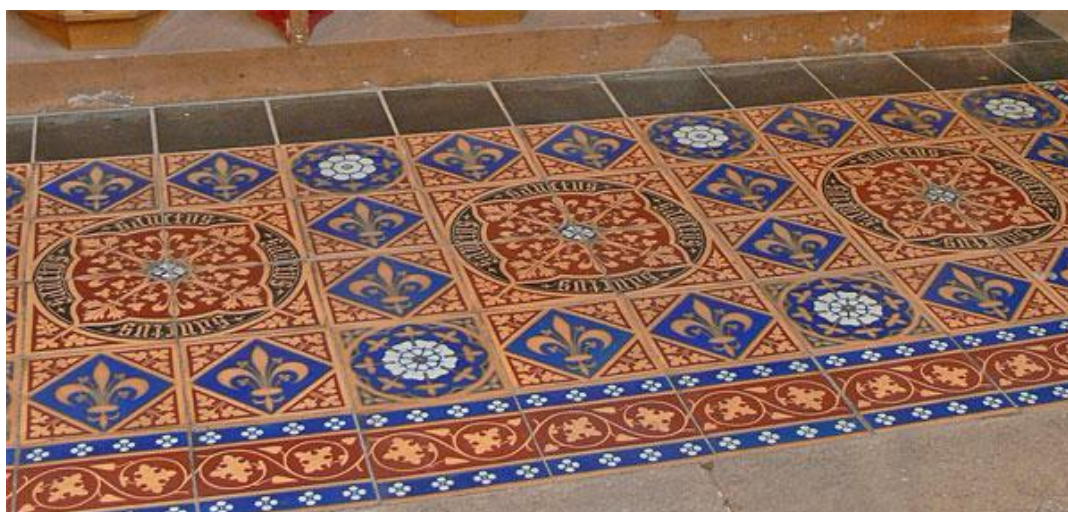
Encaustic tiles on the footpace of Pugin's altar in his chantry chapel, St Augustine's Church, Ramsgate. The altar was originally in the oratory attached to his residence, The Grange, adjacent to the church (Image: Nicholas Callinan)

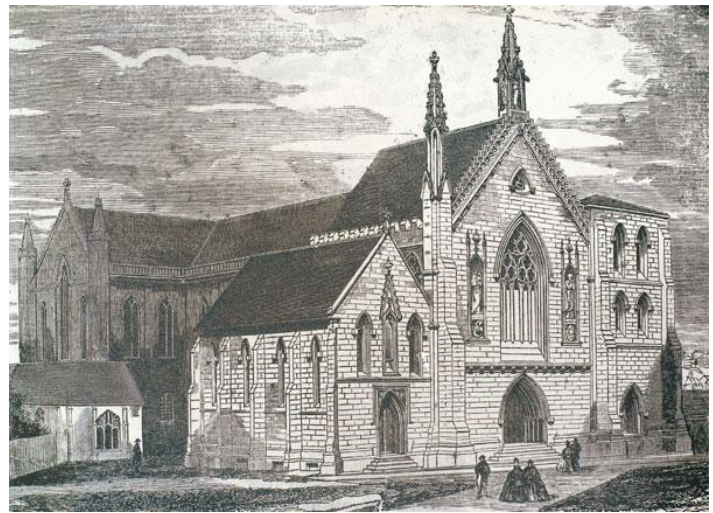
An early 1860s engraving of Pugin's incomplete extensions to St Mary's Cathedral (Source: Private collection)

In 1842 Pugin produced a design for westward extensions to St Mary's Cathedral for Archbishop Polding, with a view to the ultimate replacement of the 1830s Gothick structure by a complete new cathedral. These extensions were constructed between 1851 and c.1860, with the exception of the belfry stage and spire of the south-west steeple.

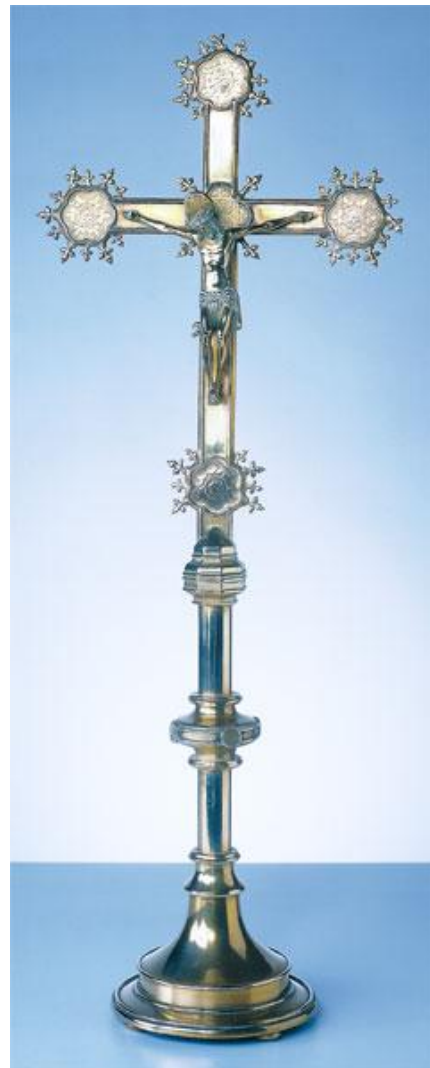
The High Altar crucifix (Image: Private collection)

The altar crucifix was purchased by Bishop Willson as part of the new High Altar ensemble, the description in the Hardman Metal Day Book 1855–57, pp. 65–6, 28 March 1855, being as follows: ‘Right Revd Bishop Willson Hobart Town Van Dieman’s [sic] Land, To an Altar and Reredos ... To a Brass Altar Cross, as 4119, but without Lions, & simply engraved in corners, not painted; 3 feet high No 4713 @ 140/– 7 0 0’.

This description situated the crucifix at the lower end of Hardman’s price range for this model and shows how they could produce a set of variations on the same basic design through the substitution and/or addition of a range of finishes. Thus, a crucifix acquired for St Marie’s, Rugby, in 1847 was from the same design but a couple of grades up in quality and price, with its crouching lion feet and engravings of the Evangelists at the extremities of the arms.

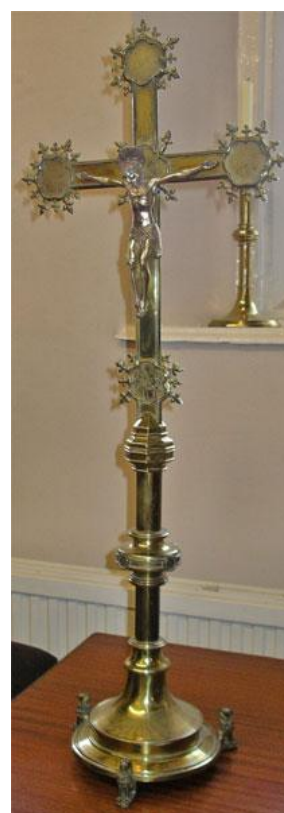
Altar crucifix, St Marie’s, Rugby (Image: Nicholas Callinan)

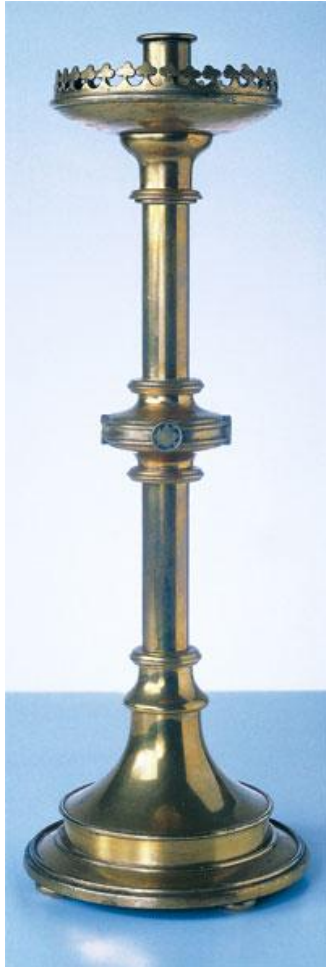
High Altar candlestick (Image: Private collection)

The candlesticks were also stock items, their Day Book entry (same page as the crucifix) being: 'Right Revd Bishop Willson Hobart Town Van Dieman's [sic] Land, To an Altar and Reredos... To 6 Brass Candlesticks 3491 @ 40/- 12 0 0'.

These candlesticks met the fate of many church furnishings in the unthinking—and frequently misguided—aftermath of the Second Vatican Council; they were removed from liturgical use.² Their ferrules were removed, then they were painted grey and converted into smoker's stands for use in the clergy lounge of the adjacent presbytery. Mercifully, two were restored for the 2002 Australian national travelling exhibition 'Creating a Gothic Paradise: Pugin at the Antipodes', and are now back in use in St Joseph's Church.

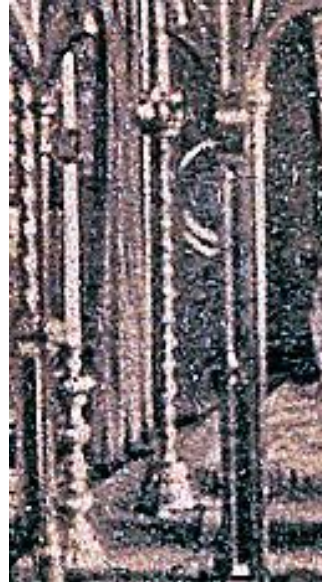
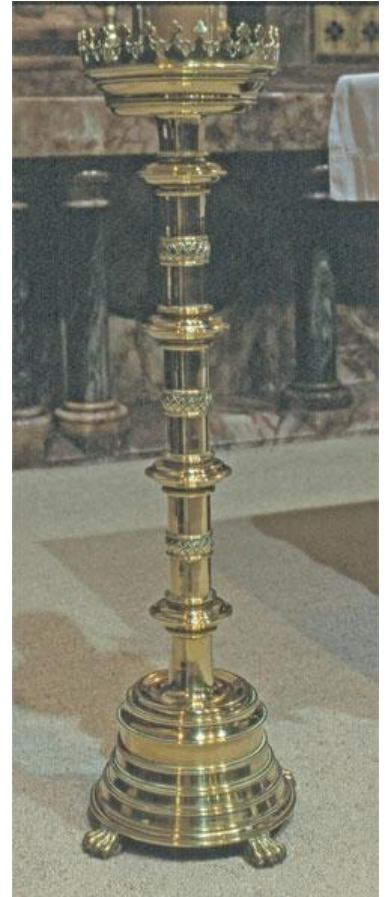
At left, the original Paschal candlestick and, at right, the cut-down version from the 1960s (Image: Private collection)

A similar fate overtook the c.1843 Paschal candlestick, another victim of liturgical vandalism and visible in the c.1859 image at the left corner of the steps leading to the altar. It was cut down in height but, at least, not discarded.

In recent days some, but not all, of the missing sections of the candlestick have been reinstated.

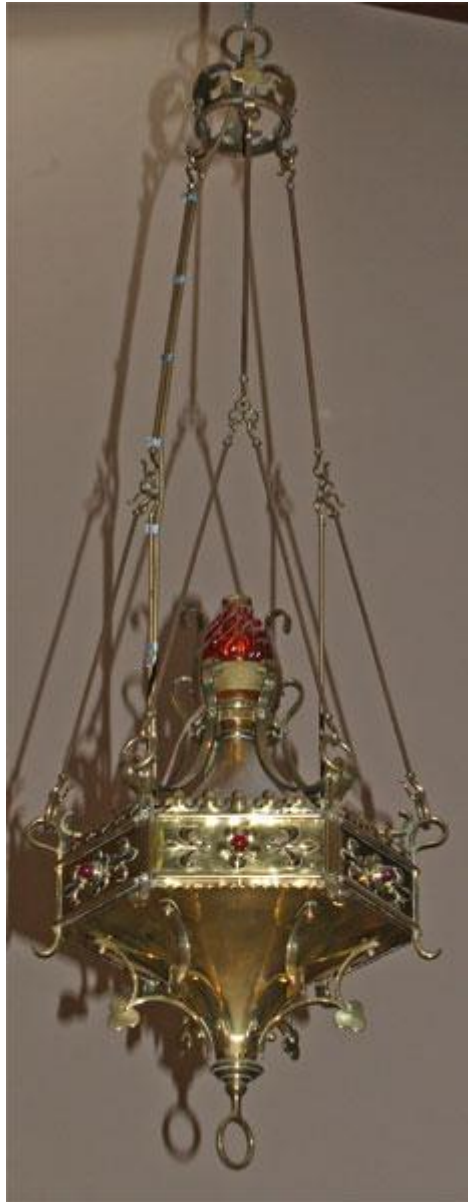
The Sanctuary lamp (Image: Brian Andrews)

Indeed, the only obvious evidence of it is in the cords visible behind the rood crucifix, being part of the counterweight suspension arrangement for the object: the sanctuary lamp.

This fine lamp, of which only the red glass lantern is not original, was most likely one of the some £306-13-9 worth of metalwork items sent out to Tasmania in 1855 on a sale or return basis by John Hardman.³ **To be continued.**

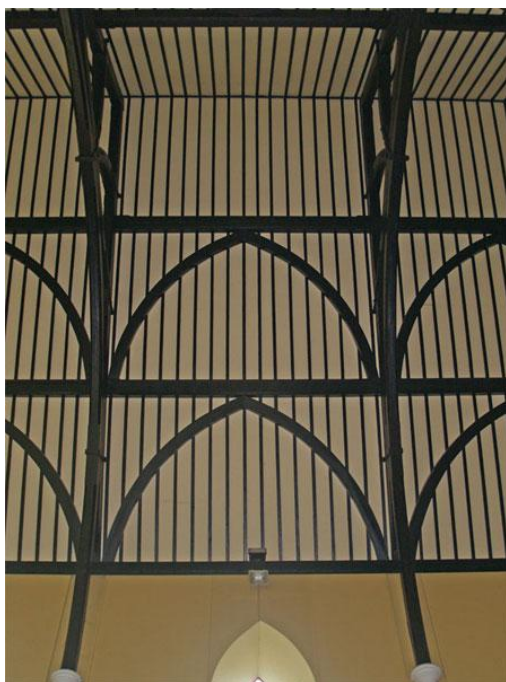
The nave roof in St James', Ramsgrange (Image: Brian Andrews)

This large church was also designed in 1838 and its nave has the same roof structure as St Peter's, Wexford, with two levels of wind bracing. The chancel has a coffered ceiling, so the roof structure cannot be seen. But insofar as the ceiling is more elaborate than the open nave roof, it is a text-book example of Pugin's theory of propriety. The likely reason for the choice of wind-bracing here is, as for Wexford, structural. **To be continued.**

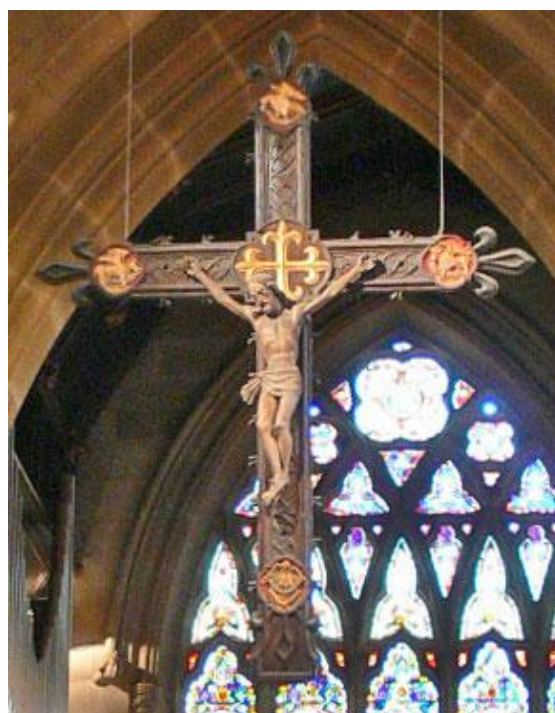
The Rood, St Augustine's, Ramsgate (Image: John Maidment)

interior a smaller rood group complete with side figures of Our Lady and St John, but then in what appears to have been a late change of mind he installed the actual rood and corpus. Both are late medieval, the rood itself without doubt from the Low Countries, but they did not originally belong together. Holes in the rood beyond the ends of the arms and feet clearly show that the original corpus for this rood was larger. Once this change had been made, the large span of the rood precluded the addition of the usual side figures in the width of the chancel arch. In this regard the Ramsgate rood screen was unique in his works.
