Number 61

- *Pugin's Window in St Mark's Church, Darling Point*
- *Pugin's Present State (Part 3)*
- *The New High Altar, St Patrick's Church, Colebrook (Part 1)*
- *Wind Braces in Pugin's Churches (Part 5)*

Welcome to the sixty-first Friends Newsletter.

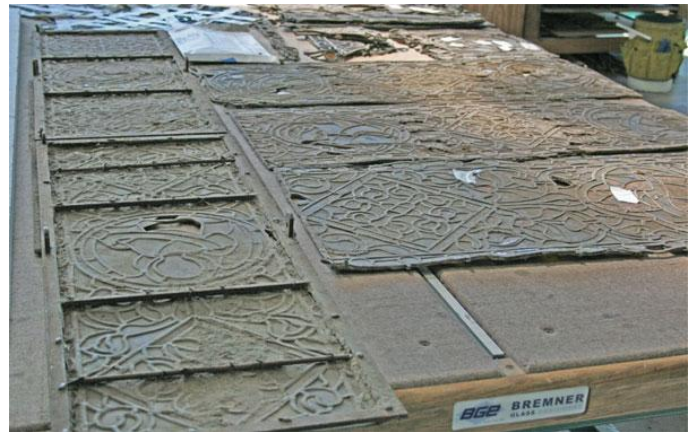
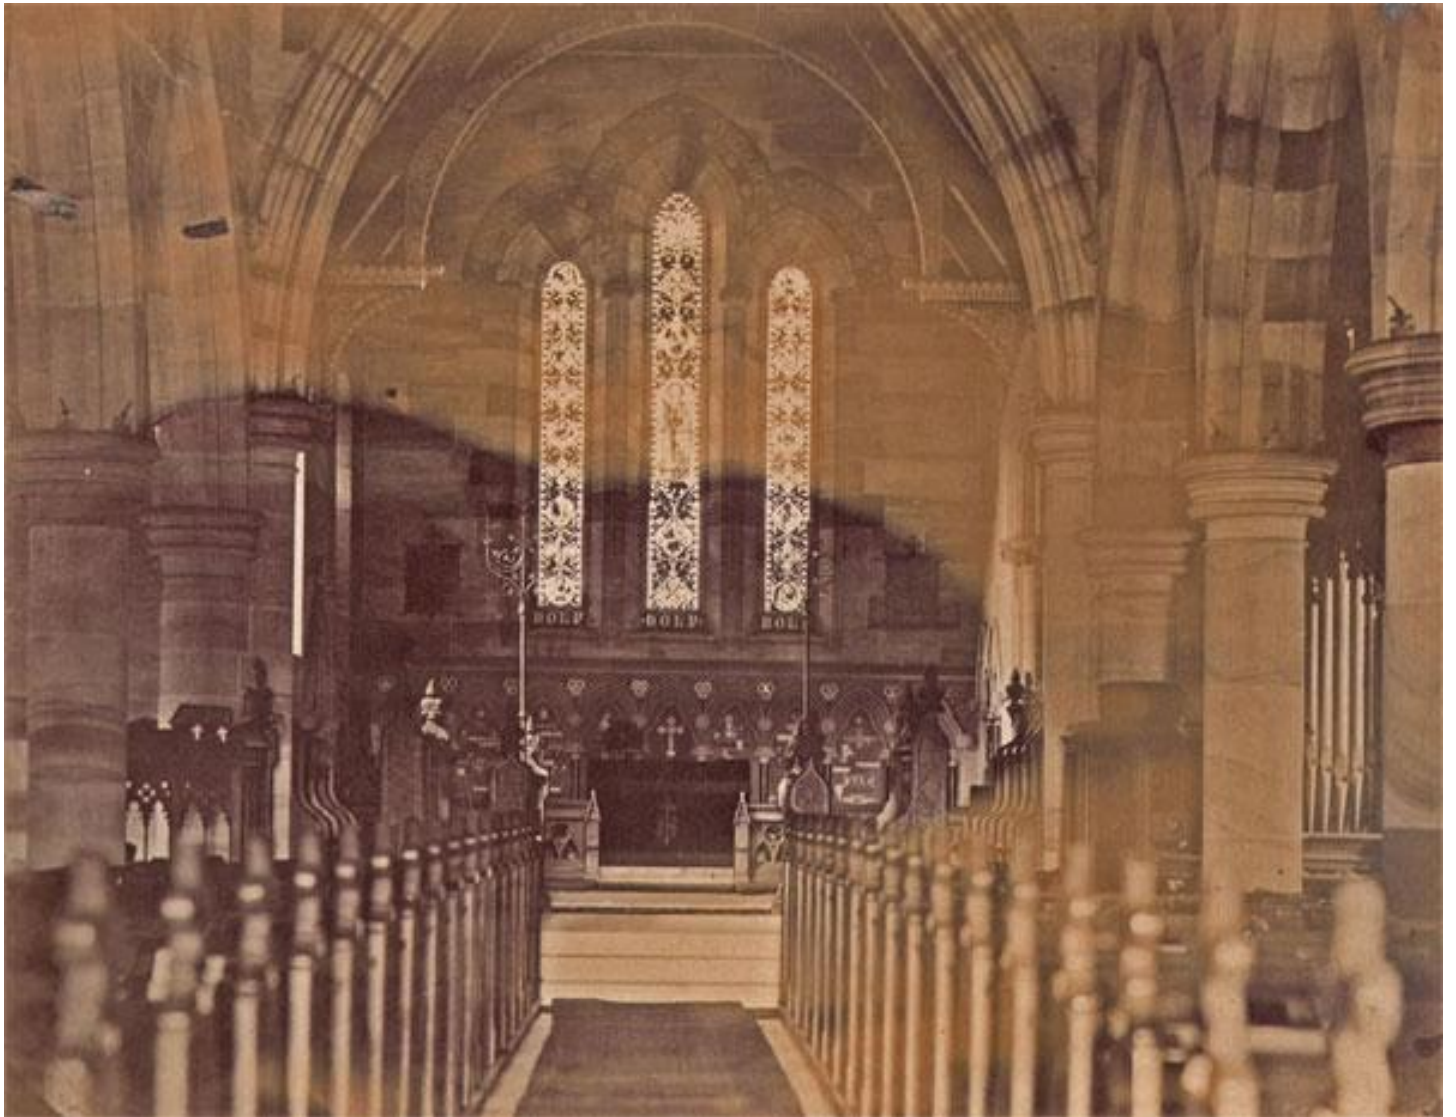
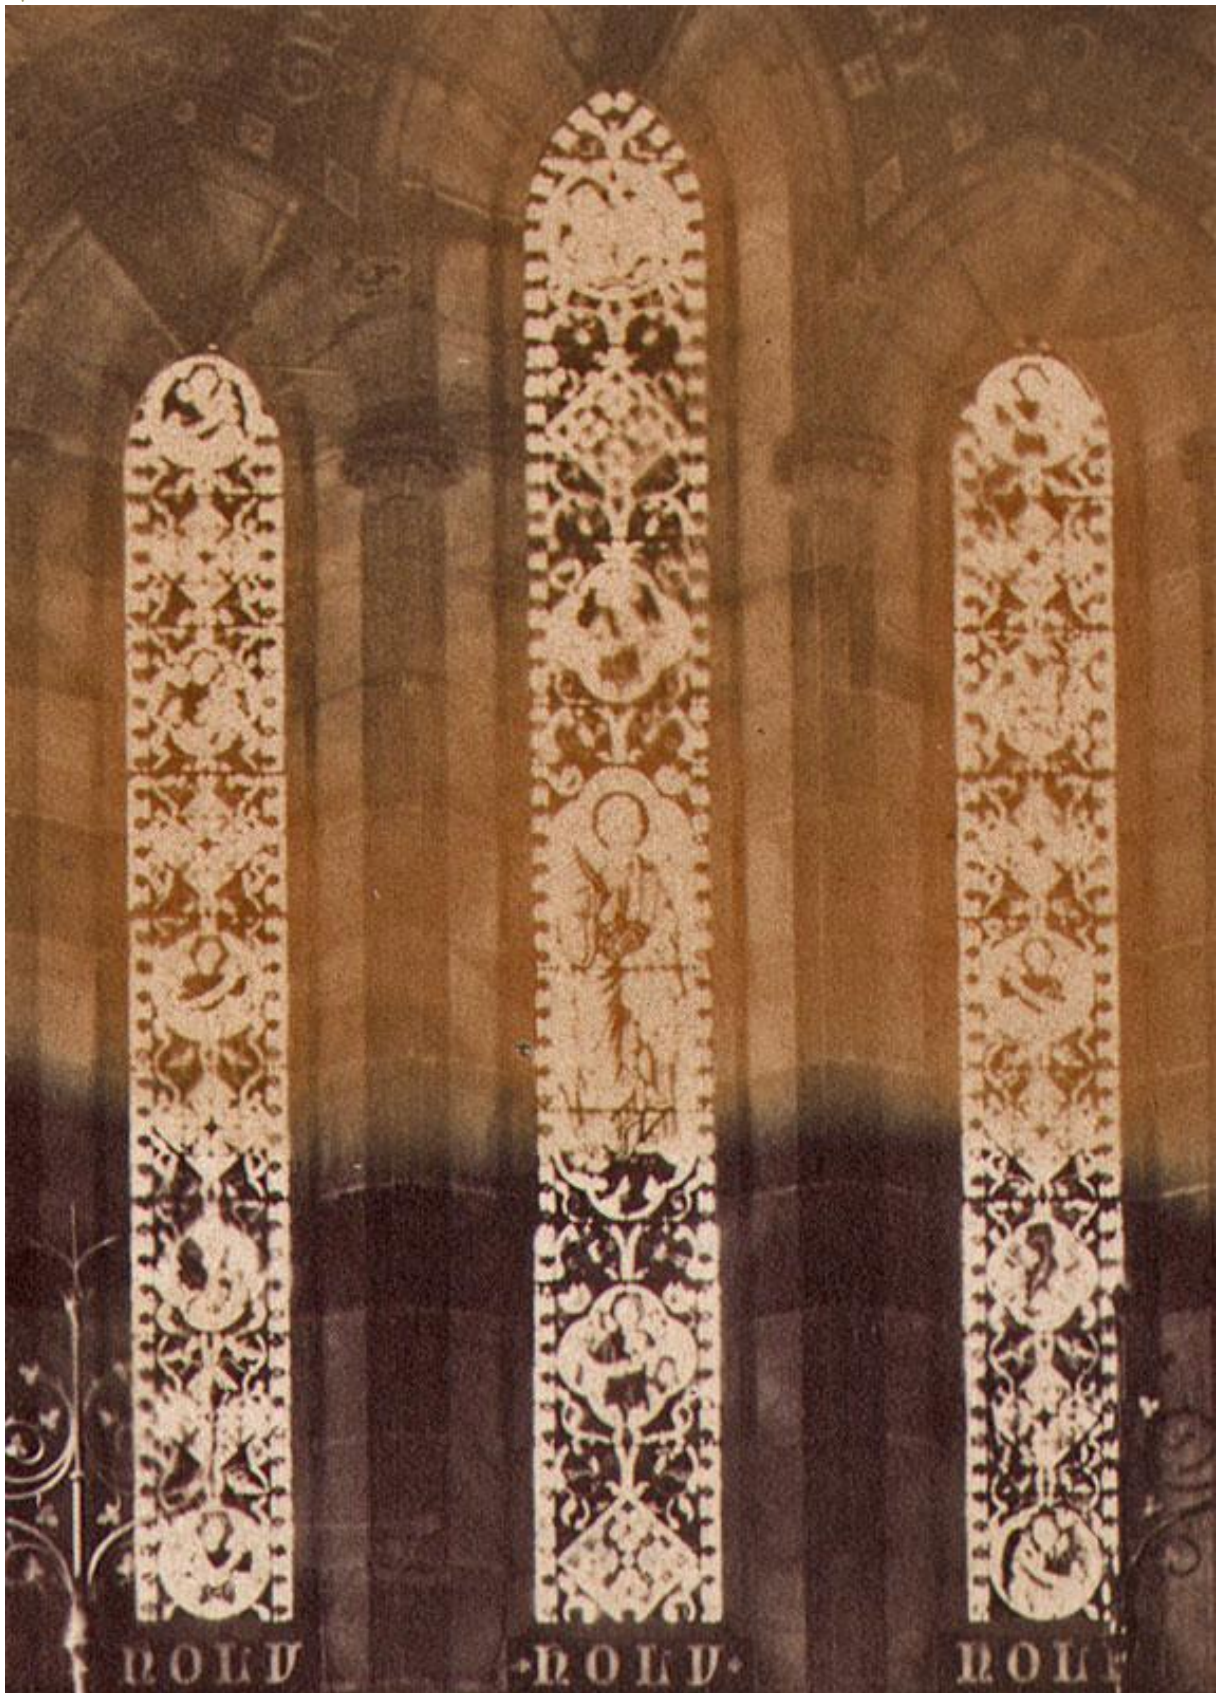
Historic image and enlarged detail courtesy David Mort

Two years ago in our October 2009 Newsletter we described the window completed by Hardmans in August 1850 for St Mark's Church. We described the severely damaged remains of the window, but at that stage no image had been identified of it in situ. Here, we are delighted to present the image discovered by Friend of Pugin David Mort, along with an enlargement of the actual window and an image showing the window's state as found.

David has taken a great interest in the fate of the window, particularly since the remains were found a couple of years ago in a sealed space above the toilets in the church hall just metres from its original site. He is doing everything possible to facilitate its restoration and re-installation in the

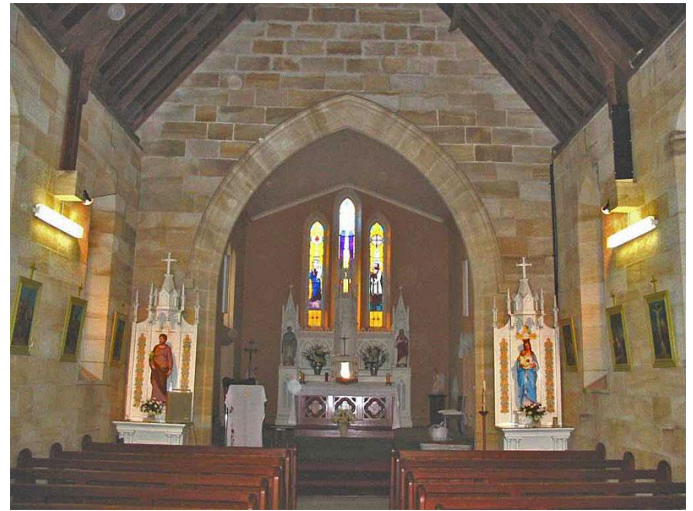
The other furnishings, in an unsympathetic and crude carpenter's Gothic idiom, were installed from a closed church in the area and can be seen in the interior view below. We have been informed that the side altars have been removed since the image was taken, and it is our hope that the truly awful high altar will follow suite.

The interior c.1995 (Image: Ray Ryan)

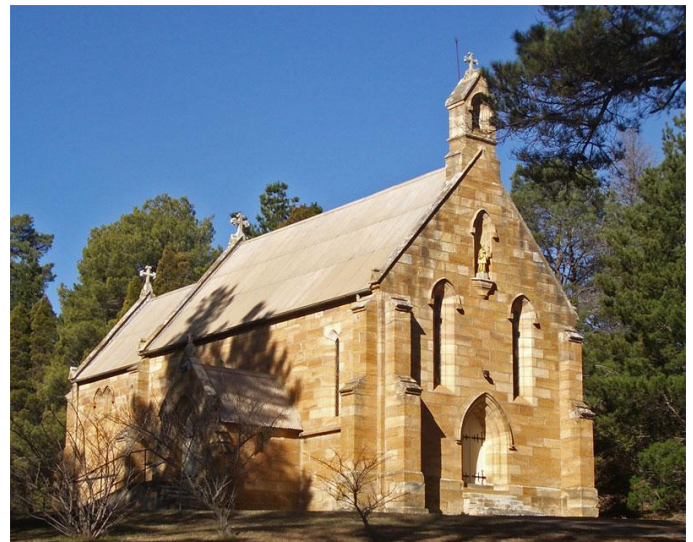
The only change to the exterior, which does not affect the original structural integrity of the church, has been the addition of a disabled ramp for the north porch entrance. **To be continued.**

The exterior (Image: Jude Andrews)

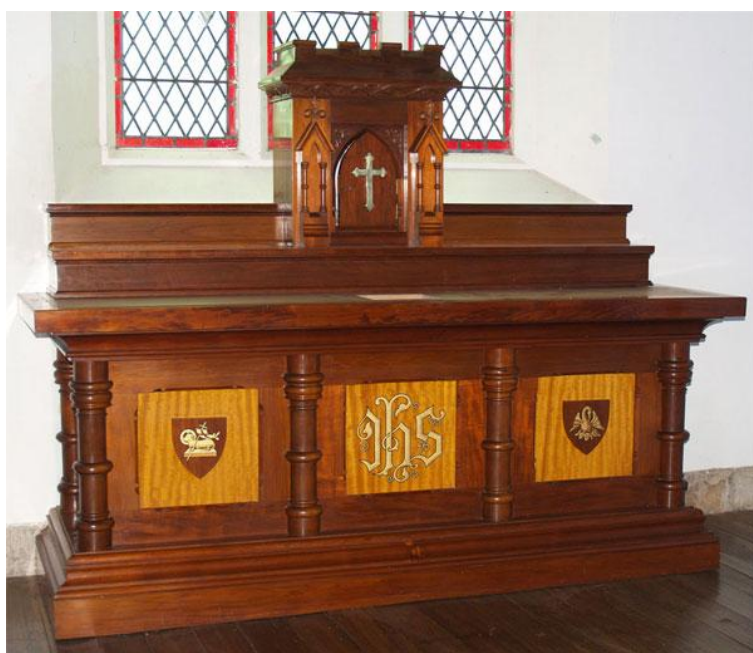
The 1930s altar (Image: Brian Andrews)

The new altar for Colebrook was likely made by the Launceston, Tasmania, furniture firm of Coogans and was constructed of the local native timber Blackwood (*Acacia melanoxylon*).¹² It was in a rather crude Gothic style, and certainly not up to the elegant standard of the Pugin interior. In September 2011 the altar was transferred to the Archdiocese of Hobart Museum. **To be continued.**

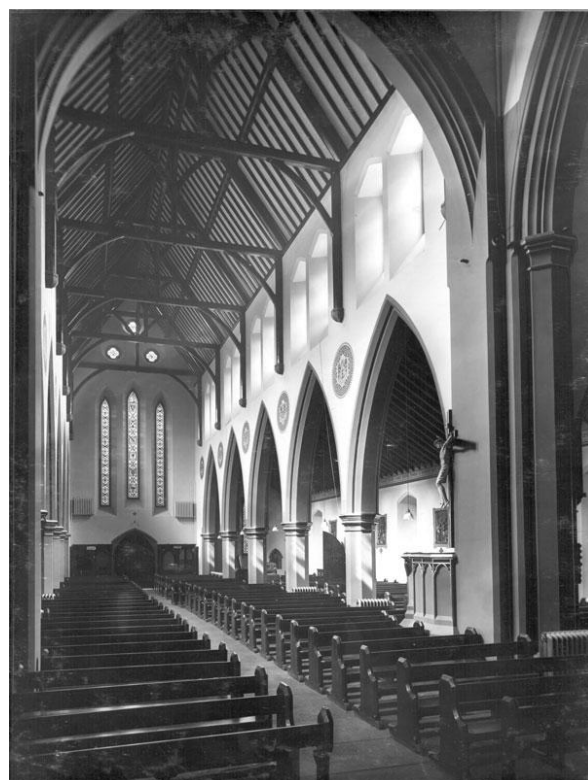
*An early 1930s image of the Nottingham Cathedral nave
(Source: Diocese of Nottingham Archives)*

Similar in size to Mount St Bernard's Abbey Church, it was furnished with wind braces in the chancel but not in the nave or transepts. Given the structural illogicality of this scheme, it must be concluded that Pugin included braces in the chancel for reasons of propriety.

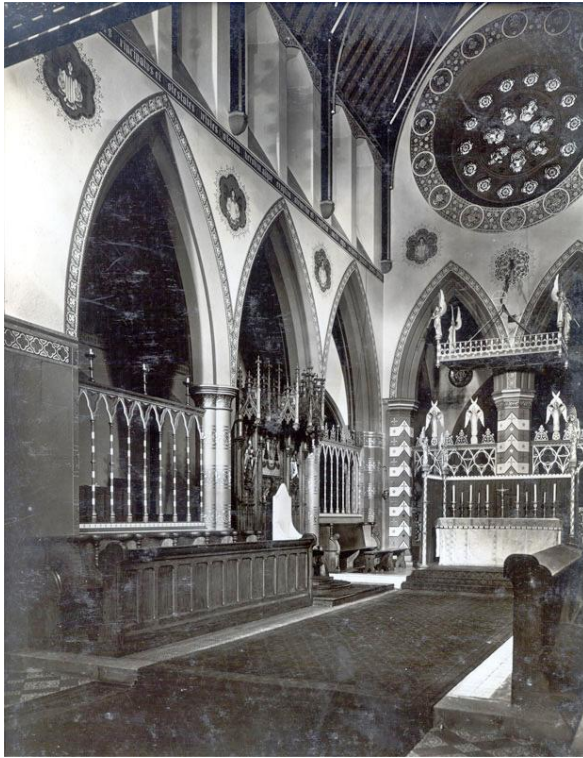
*An early 1930s images of the newly refurbished chancel of St Barnabas' Cathedral, showing wind braces in the roof
(Source: Diocese of Nottingham Archives)*

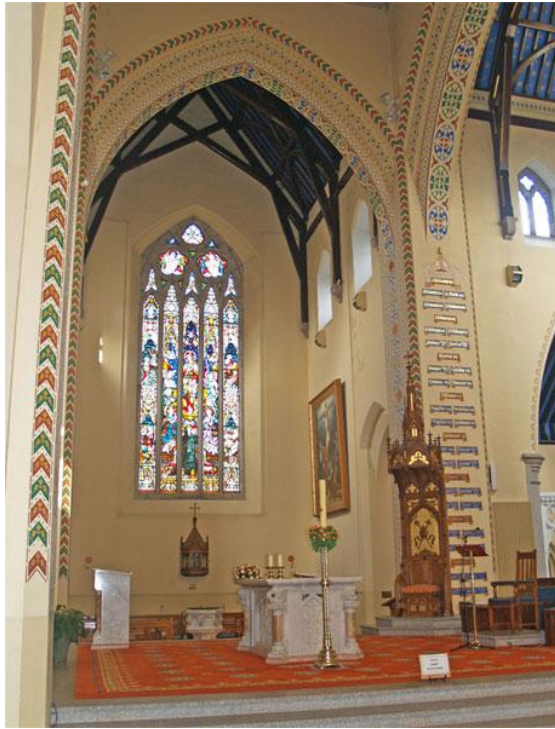
A view into the north transept of St Aidan's Cathedral showing the arch-braced roof (Image: Brian Andrews)

Designed in 1843, St Aidan's Cathedral, the third large building with the same typology as Mount St Bernard's Abbey and St Barnabas' Cathedral, had arch braces to the nave, transepts and chancel. This cathedral seems to be a case where the bracing was included for structural reasons because the building itself is not particularly structurally elaborated. Indeed, Pugin's Irish churches were generally more rugged and sparing than his English designs.

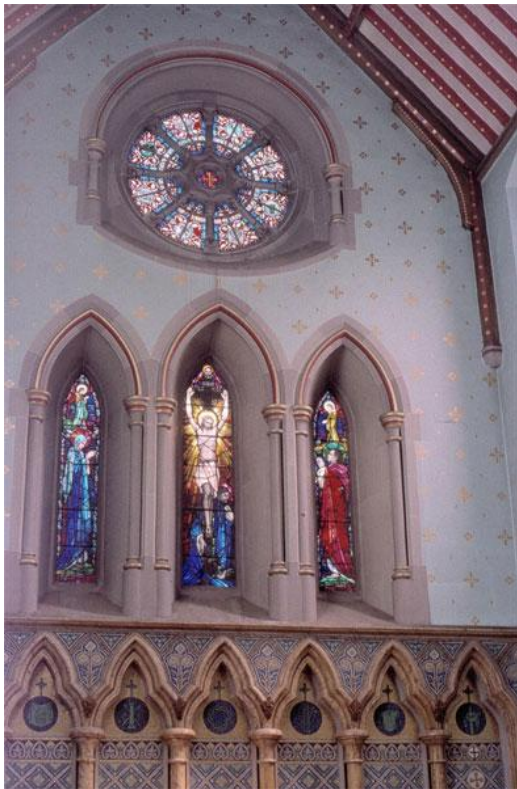
Hulme chancel roof detail (Image: Brian Andrews)

The chancel roof as constructed is shown below.

The church was opened in 1842, yet as late as May 1841 the image of the Hulme chancel in Pugin's 'Present State' article of that date showed elaborate wind bracing to the chancel roof. Given that the church had been designed in 1838 at a time when Pugin was using wind bracing for decorative purposes or for reasons of propriety, it would seem that by the early 1840s he had largely abandoned such practices. **To be continued.**
